THE SPECTRUM OF HAZARD AND RISKS IN CONSTRUCTION

In this chapter an attempt is made to classify the risks inherent in construction in such a way that a spectrum may emerge identifying the risks that one might expect.² If these expectations are clearly understood, attention may then be focused on which risks should be expected on a particular project and how they could or should be dealt with.

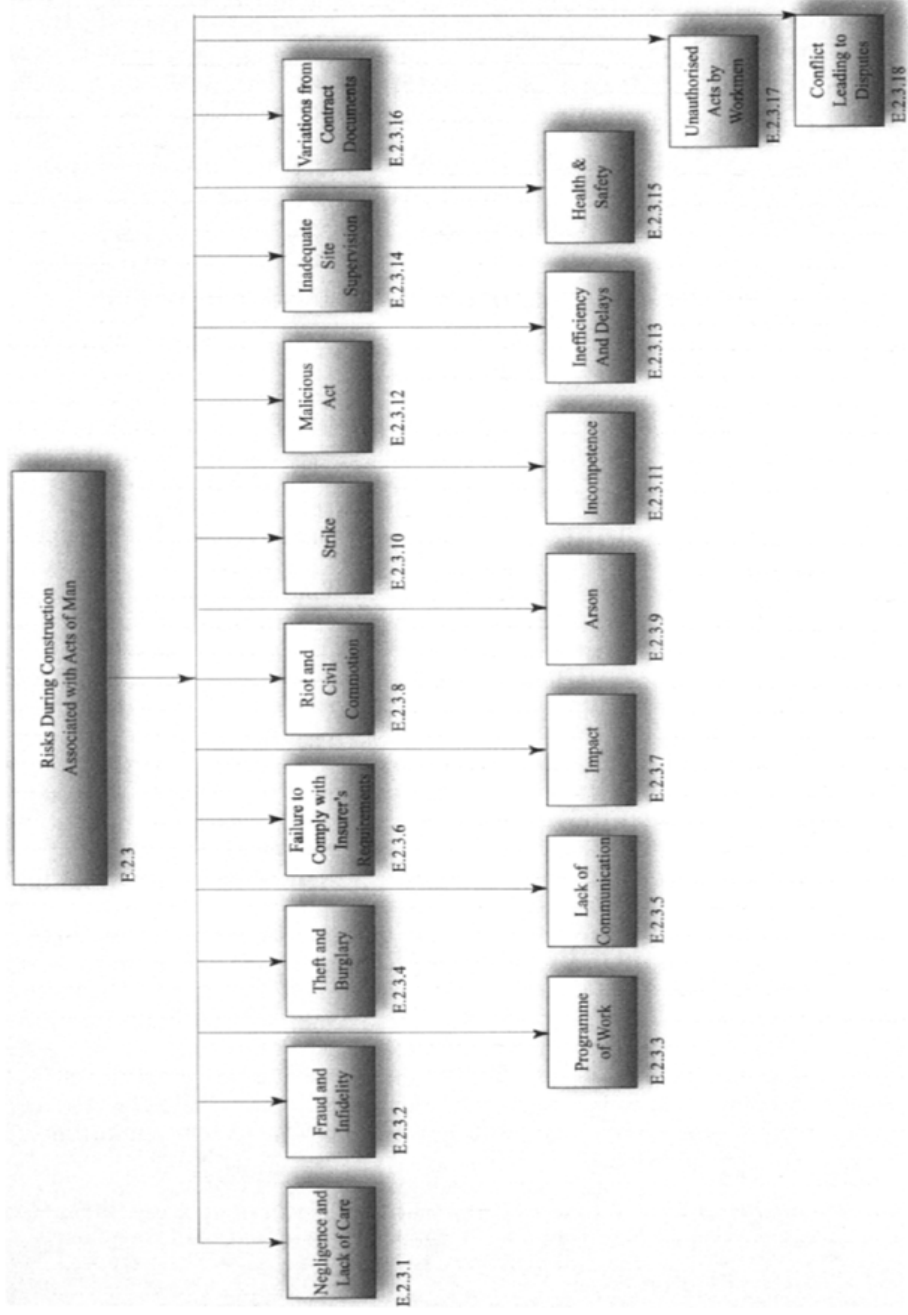
Figure 3.9 Risks during construction associated with Acts of Man.

Risks during construction associated with Acts of Man (Figure 3.9)
